A corrosion study of the effects of copper and silver ionisation on galvanised pipes.

Conrad Chapman

23/8/2017

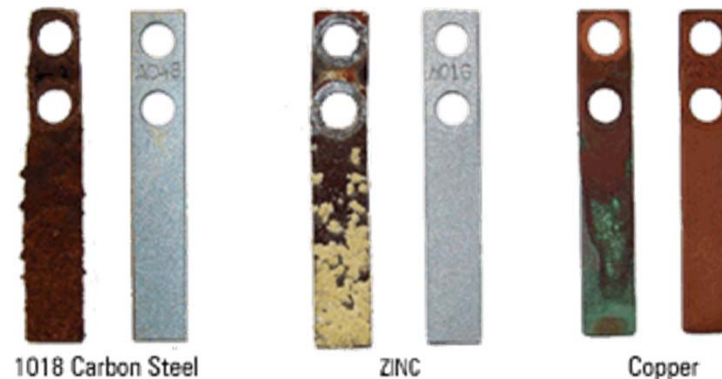
- Suggested that CSI causes corrosion in galvanised pipes of drinking water networks*
- Deposited Cu on the coupons caused extensive corrosion, especially after shut down.

- × Not a dedicated corrosion study but focused on Legionella control
- × Outdated technology used in lab circulation loop
- × Used alloy electrodes, shown to be less accurate⁺
- × Cu concentrations not measured using a standard method and Ag not measured.
- × Uncontrolled dosing, leading to Cu concentrations ~ 2000 ppb

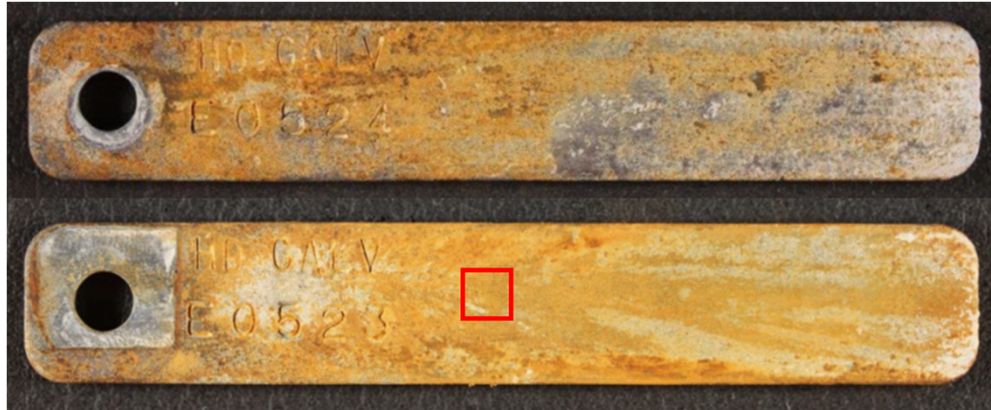
Before CSI unit

Top: after 58 days

- Red iron rust 70% coverage
- Corrosion rate (after chemical cleaning) **0.11 mm/year**

Bottom: after 127 days

- 80% red iron rust coverage
- Corrosion rate (after chemical cleaning) **0.08 mm/year**
- Corrosion rate (after mechanical cleaning) **0.11 mm/year**
- Rust layer was extensive which could not be cleaned off with chemicals
- Localised loss of Zn layer

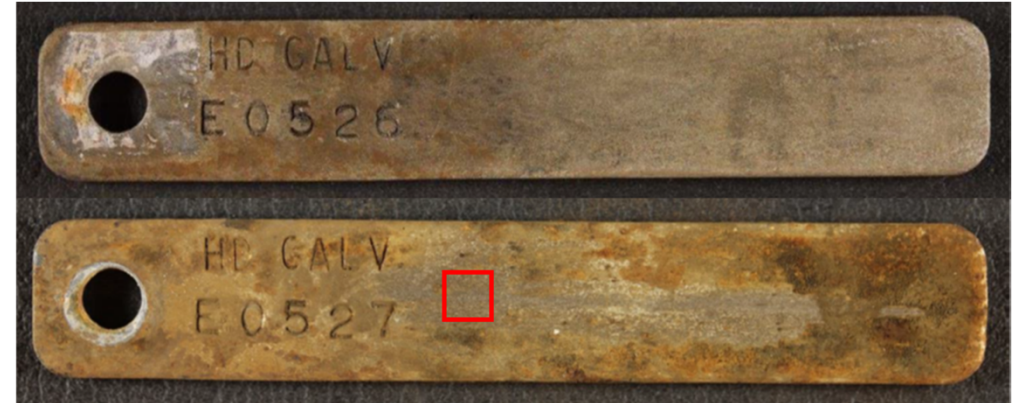
After CSI unit

Top: after 58 days,

- Red iron rust 20%, 7% Ag
- Corrosion rate (after chemical cleaning) **0.14 mm/year**

Bottom: after 127 days,

- 60% red iron rust, 20% Ag
- Corrosion rate (after mechanical cleaning) **0.11 mm/year**
- More uniform corrosion layer
- Corrosion layer more superficial

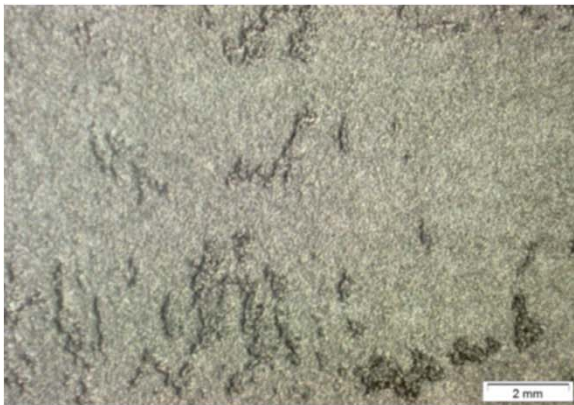
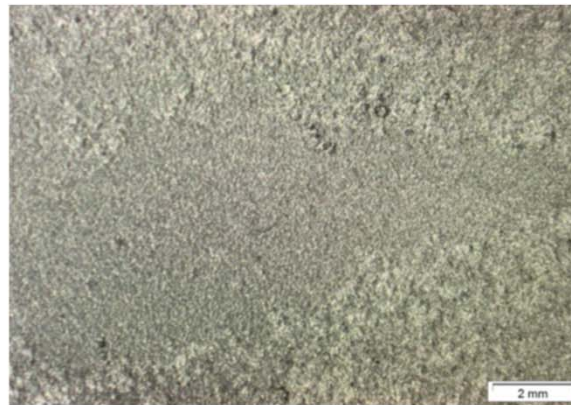
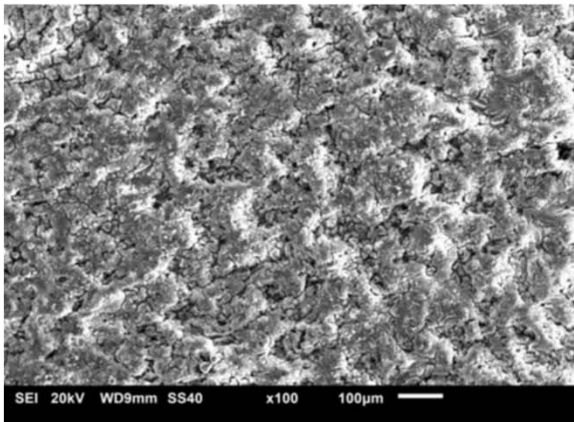
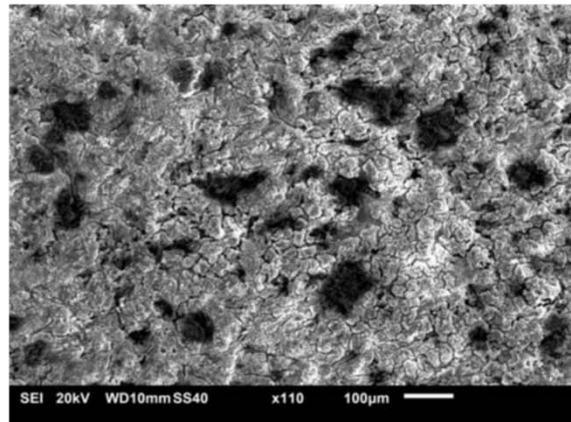
Microscopy after 127 days

Before CSI

After CSI

- More localised pitting on the before coupons
- Visual evidence of the Ag build up using SEM

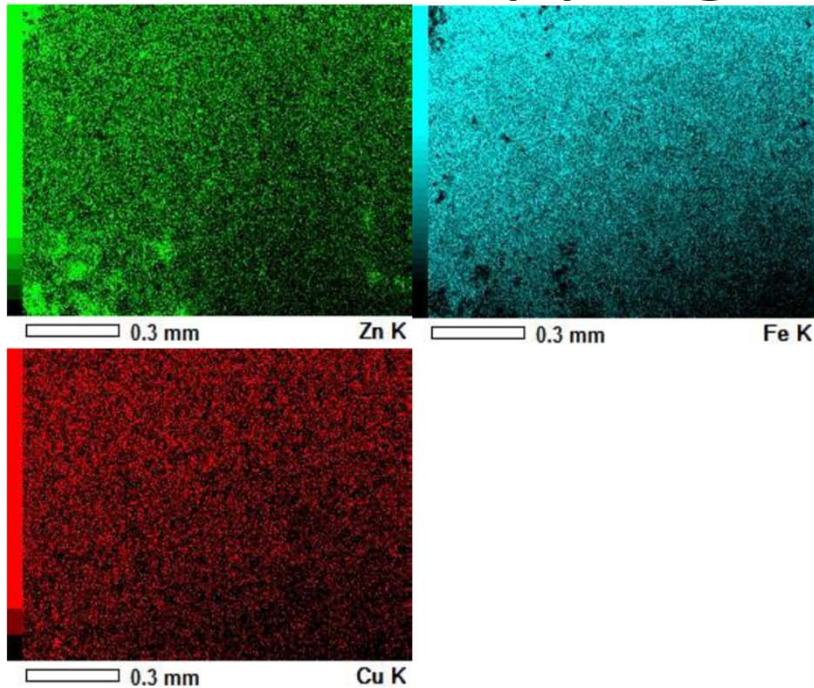
Before CSI:

- Cu <0.5 ms%
- Fe 36 ms%
- Zn 8 ms%

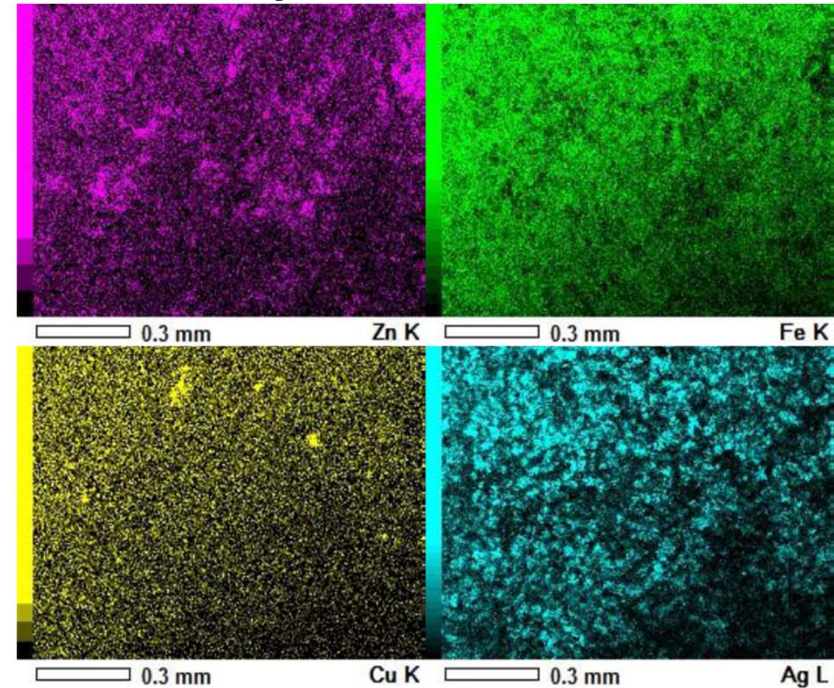
After CSI:

- Cu 4 ms%
- Ag 20 ms%
- Fe 23 ms%
- Zn 6 ms%
